Manhole Inspection Summary

Manhole # S17II1001MH

Location Address: **2319 DERBY RD**

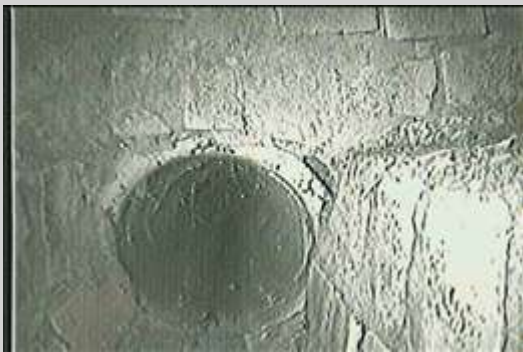
8 in. Circular Gravity Sewer Pipe Out @ 12 O'Clock

Rod and Bar (Angled)

Pipe Material: **Clay** ☐ Pipe Lined

Infiltration: **None** Pipe Seal Cond: **Unknown**
